Success of long term preventive maintenance on telescope subsystems using the example of the VLT Adapter-Rotators at the ESO Paranal Observatory

F. Salgado* , J.Haddad, G.Hudepohl, R.Medina
European Southern Observatory, Paranal, Chile.

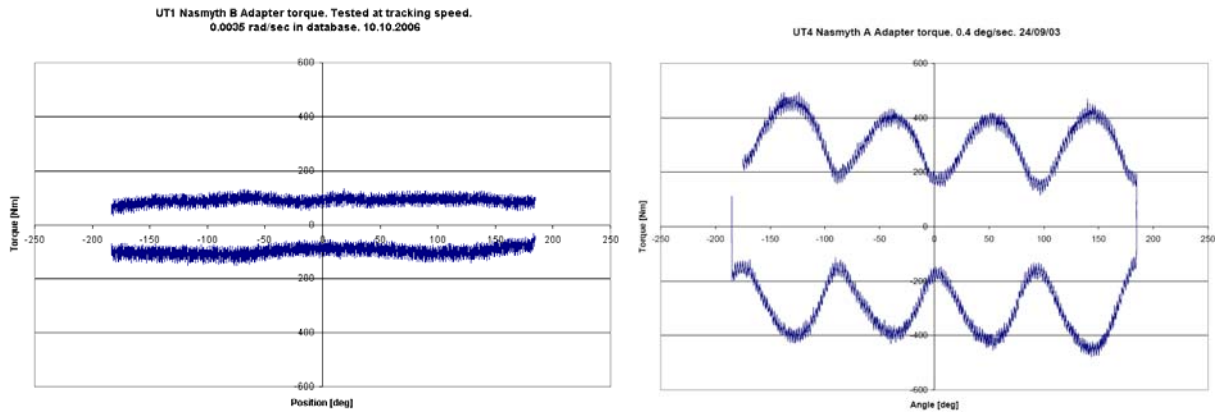
Maybe the most emblematic intervention was this, an Adapter got stuck in UT4 Nasmyth A in August 2004, some sand came from inside of its structure reaching its bearing. The complete unit was dismounted from the telescope and moved to basecamp for several months for complete cleaning and replacement of the bearing cage. First warning was the following torque curve observed there moving it through complete range which was completely different to a normal one (showed in following chart)

Figure 2. Torque signal versus position for a normal and for a strange Adapter behavior before to get stuck.

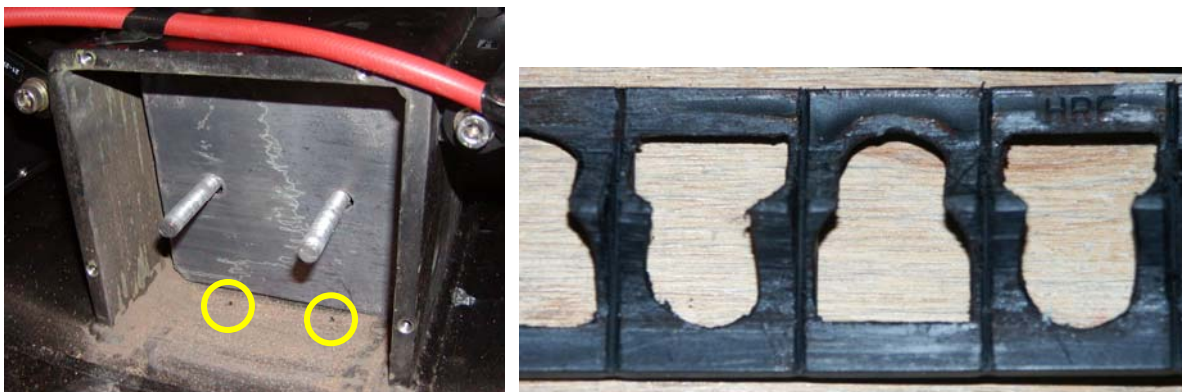
After investigation it was found that the sand came from inside of the adapter structure passing through a counterweight. The bearing got stuck and a big intervention was needed, removing the complete Adapter rotator from telescope and moved to base camp where was completely disassembled and cleaned. The following charts show the adapter rotator resting in horizontal position in base camp, the counterweight box with 2 holes where the sand came out, the damaged bearing cage and one of the damaged cylinders too. Unfortunately the cage was not available anymore so the supplier provided an optional one which generated a strange behavior when the Adapter is changing direction.

Figure 3. Counterweight box where the sand came from inside of structure through these 2 holes, and the damaged cage are showed.

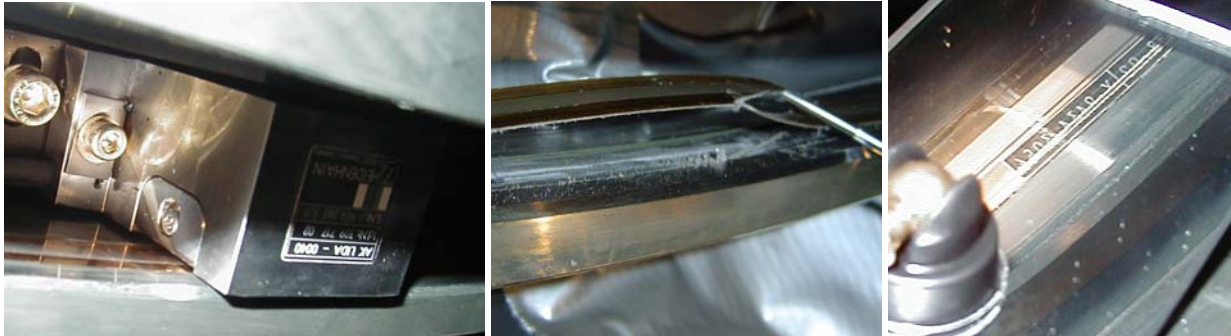
The encoder heads originally had a plate in the side that in this case was found a bit rotated enough to start damaging the tape forcing finally to replace it in UT4 Nasmyth B where NACO is mounted, this big intervention was done by people in Paranal following a procedure by Heidenhain. Through following years those plates were removed from all encoder heads in order to avoid a similar damage in other unit.

Figure 4. These pictures show the encoder head and the damaged encoder tape finally replaced.

This was the first time at ESO that a replacement of a big encoder tape is done and the result was successful, this unit is used now in normal operation.

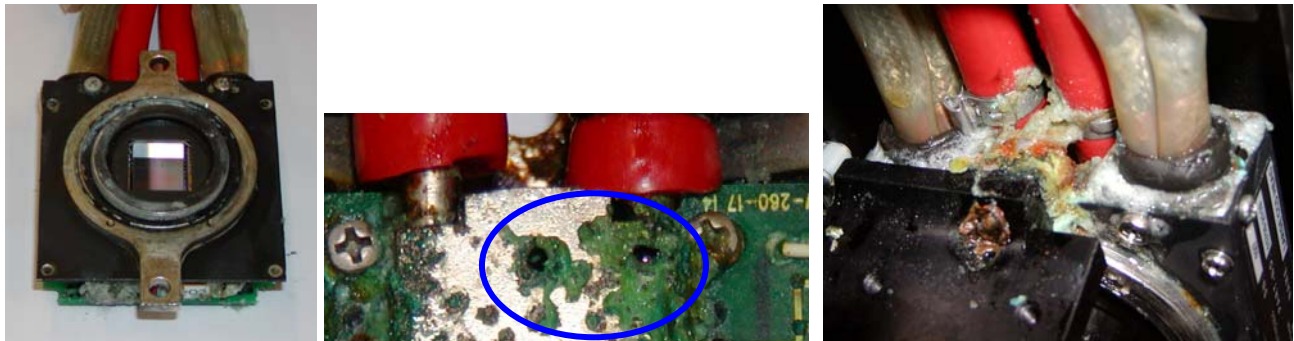
There was cooling leak in a TCCD in UT3 Nasmyth B in July of 2003, VIMOS was already installed there, the following picture shows the cooling leak holes in the head, from where cooling liquid was flowing inside of Sensor arm, reaching optical components and adapter structure, an encoder head got damaged.

Figure 5. These pictures show the damaged TCCD

It was a clear signal that a replacement of TCCDs was needed.

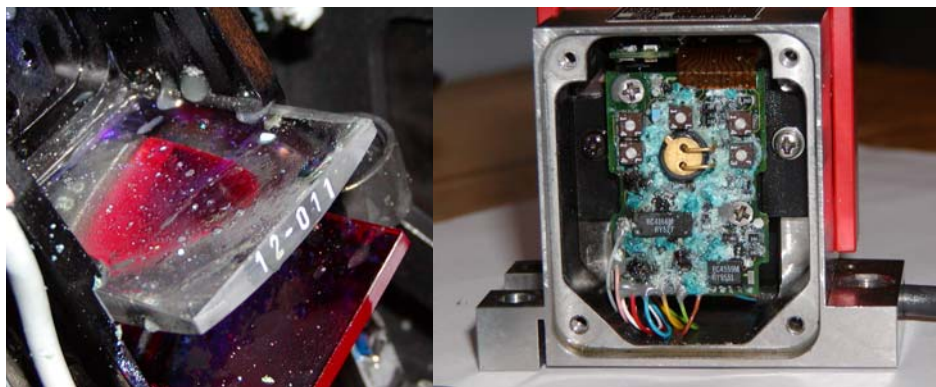
Figure 6. These pictures show some optical components and the damaged encoder head.

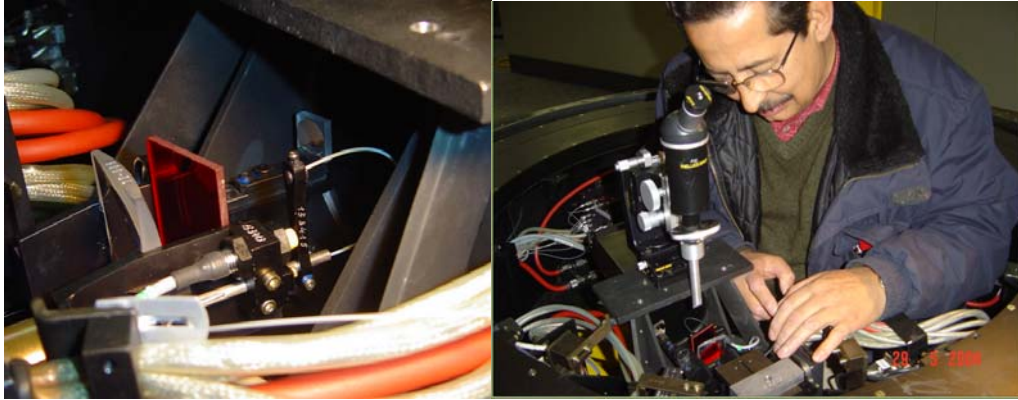
There is a reference star generated in a source located in LCU side and transmitted by a fiber to the Sensor arm, passing through the Adapter cablewrap. It rests in a small arm that moves in and out of beam, this fiber is getting older and replacement has been needed in several of them. This light is used as reference to calibrate and test Image Analysis system and Autoguider too. In some cases that failure forced to get access to the system leaving an instrument out of service during some days.

Figure 7 Replacement of a fiber in a Sensor arm.

This was modified to provide a better adjustment.

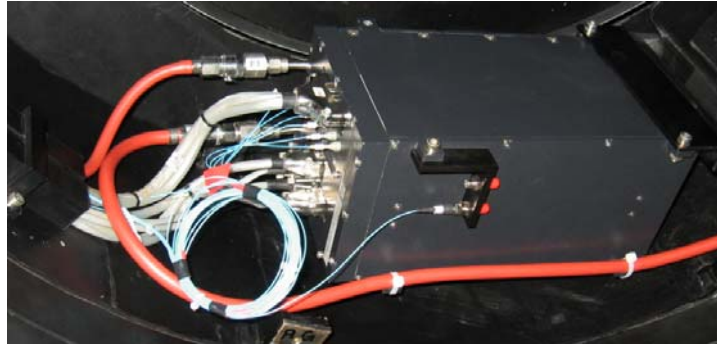
Figure 8 Acebox and optical fibers connected

The ACE-Box for technical CCD for I/A and A/G are connected to the LCU using fiber for control and data acquisition. The fiber for that application was selected more than 10 year ago, when there was few alternatives, it is not an standard cable, it is home made, too fragile, not confident difficult to replace, and is difficult to maintain, today there are new more confident technologies to use in that application, like the new MTP connector and the Mini Core Cable , both offers up to 12 times the density of standard connectors, providing significant space, ease to replaced and cost savings.

There is another set of fibers used for communication between Autoguider and Image Analysis aceboxes and LCU, several of them have been damaged by aging and replacement was done too. As soon as there is an option to get access to an Adapter the old sets are replaced by new ones. The replacement of old TCCDs implies that these fibers are not used anymore and just a pair is needed.

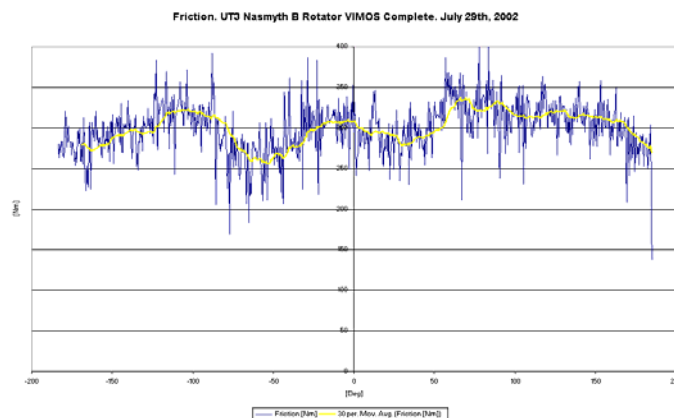
The following chart shows a case [2], where the effect of having a damaged support wheel could be reflected in the torque measured in Rotator, it shows a noisy torque, some of bigger peaks coinciding with junctions points in the wheel and second one for the improved situation.

Figure 10 Torque measured while Rotator is moved in whole range with a damaged supporting wheel in VIMOS

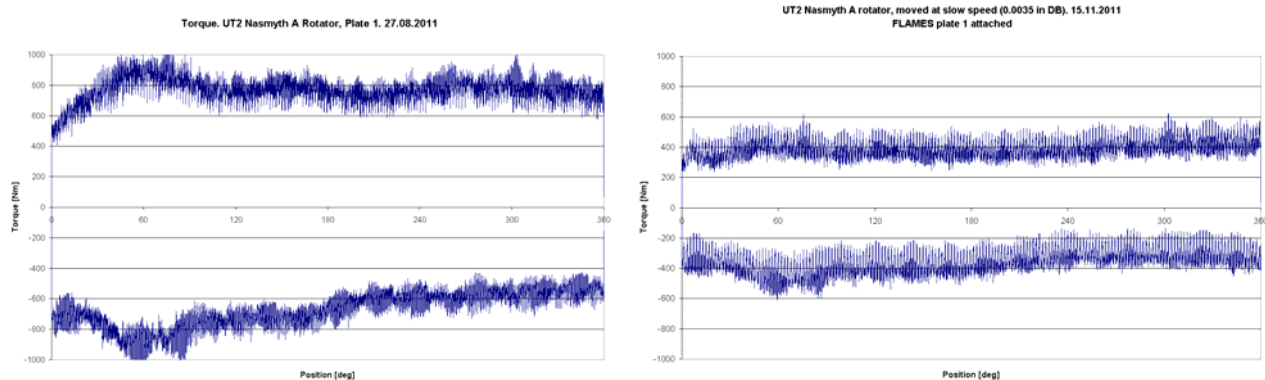
Figure 11 Example of reduction of friction after an intervention in UT2 Nasmyth A rotator, FLAMES, left chart shows an average of 800 Nm reduced to half the value in the right side, by greasing and improvement of brake system.

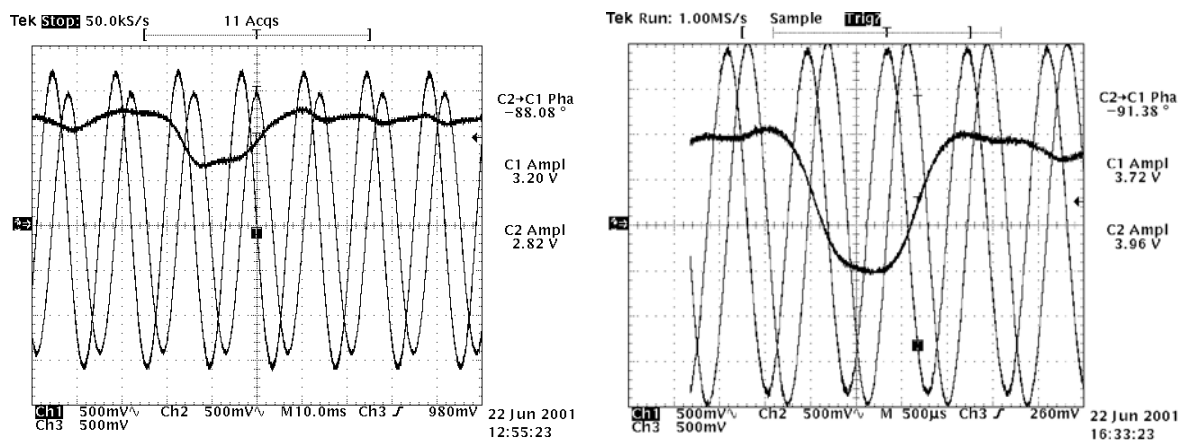
Figure 12 Example of bad (left) and good (right) status of an encoder head obtained by maintenance devices.

Heidenhain Encoder signals are measured periodically too using electronic tools provided by supplier, so if any deviation is detected it can be solved before it gets out of service. People have been trained to read those signals and get conclusions before to open it, it is possible to know in advance if there is an alignment needed or just cleaning of tape and heads.

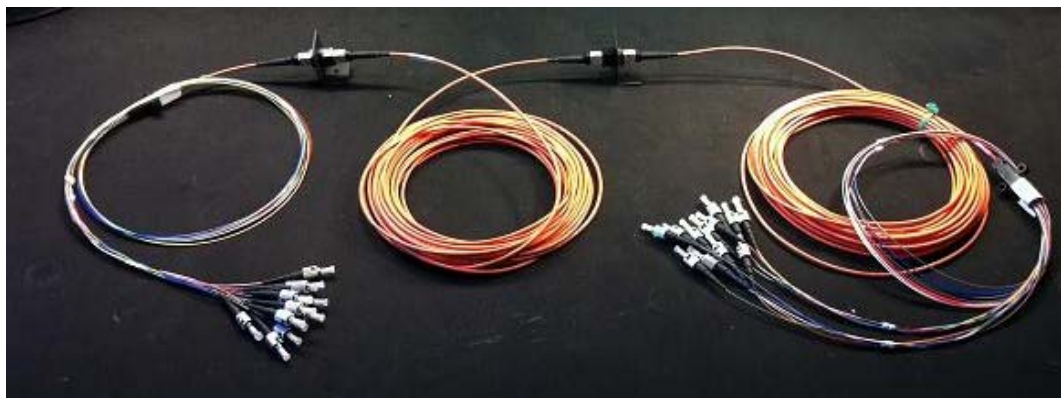
Figure 14 Old fibers were first replaced for new technology ones.

Each time that there is access to an Adapter Rotator the old set of fibers is replaced by a newer one to avoid that the aging process forced to a an unexpected intervention.

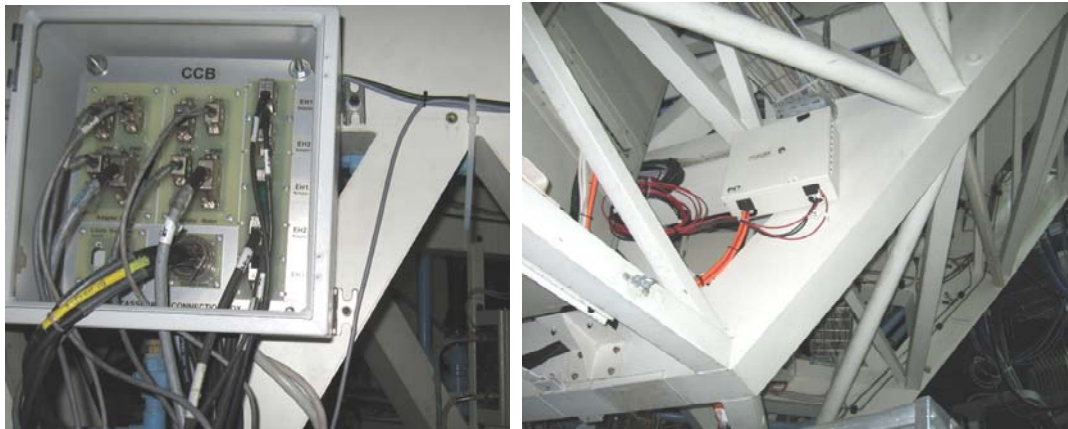
Figure 15 New junction boxes were installed inside of the M1 cell to avoid getting access to LCU, that was difficult and slow, an important reduction of time dismounting the Cassegrain adapter rotator was achieved thanks to this improvement.

An additional junction box was installed inside of the main mirror cell to give a better access to disconnect Cassegrain adapter rotators when it is dismounted for interventions like it is done each time that a coating of main mirror is on going. Before it was done disconnecting directly from LCU which access to is very complicated.
