Success of long term preventive maintenance on telescope subsystems using the example of the VLT Adapter-Rotators at the ESO Paranal Observatory

F. Salgado* , J.Haddad, G.Hudepohl, R.Medina
European Southern Observatory, Paranal, Chile.

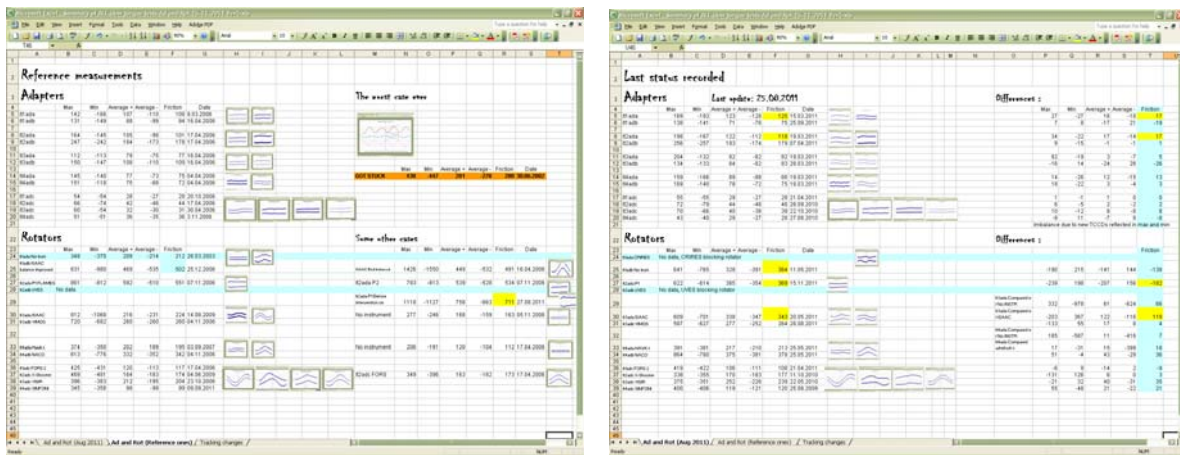
Figure 9 Torque measurements for all adapters and rotators, a healthy measurement and last status recorded to be compared.

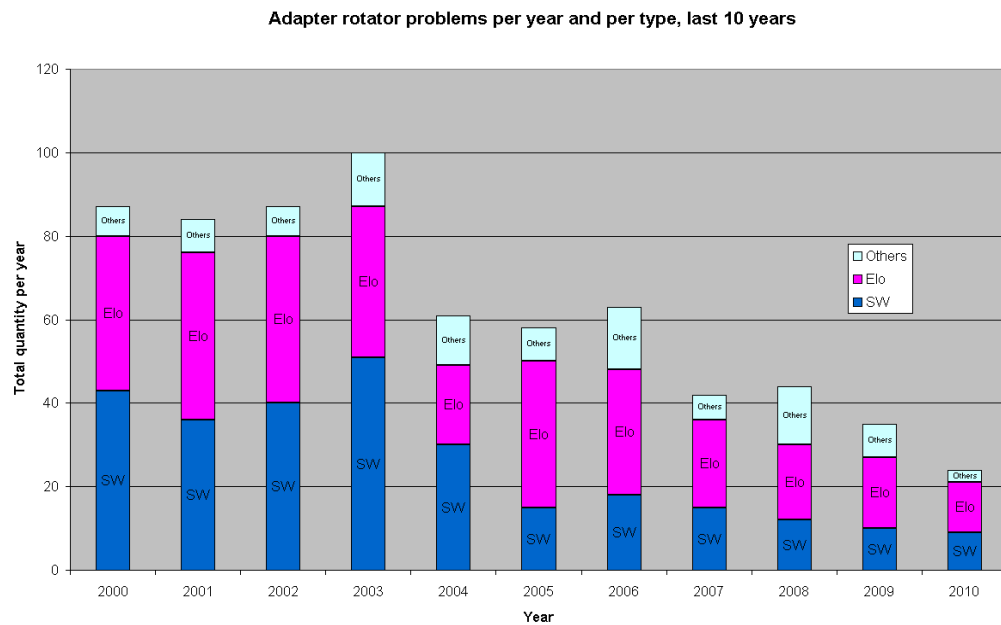
The script to test torque in adapters and rotators and other preventive actions started to be implemented in 2004, next charts show a jump on that year, when number of problems decreased.

Figure 16. This chart shows the evolution of problems during last 10 years classified by type of problem as electronics, software or others including optical, mechanical, etc. Elo means electronics, SW means software and Others include optical, mechanical, etc.

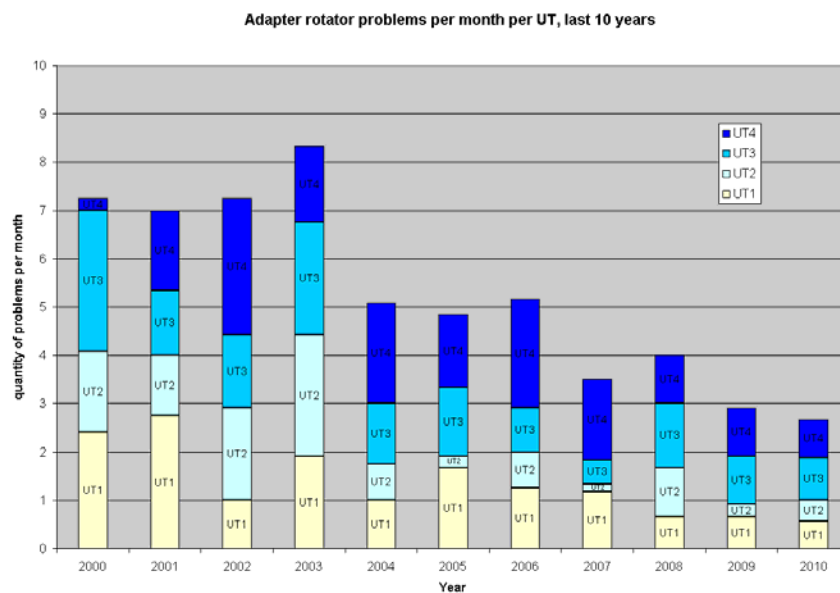
Figure 17. This chart shows the evolution of problems during last 10 years too but classified by telescope, where UT means unit telescope.

No more big forced interventions have been needed since those preventive actions have been implemented.
