# Report joint workshop on NGTCCD Garching 9-22 Nov 2006

Peter Sinclair (La Silla) & Philippe Duhoux (Garching)

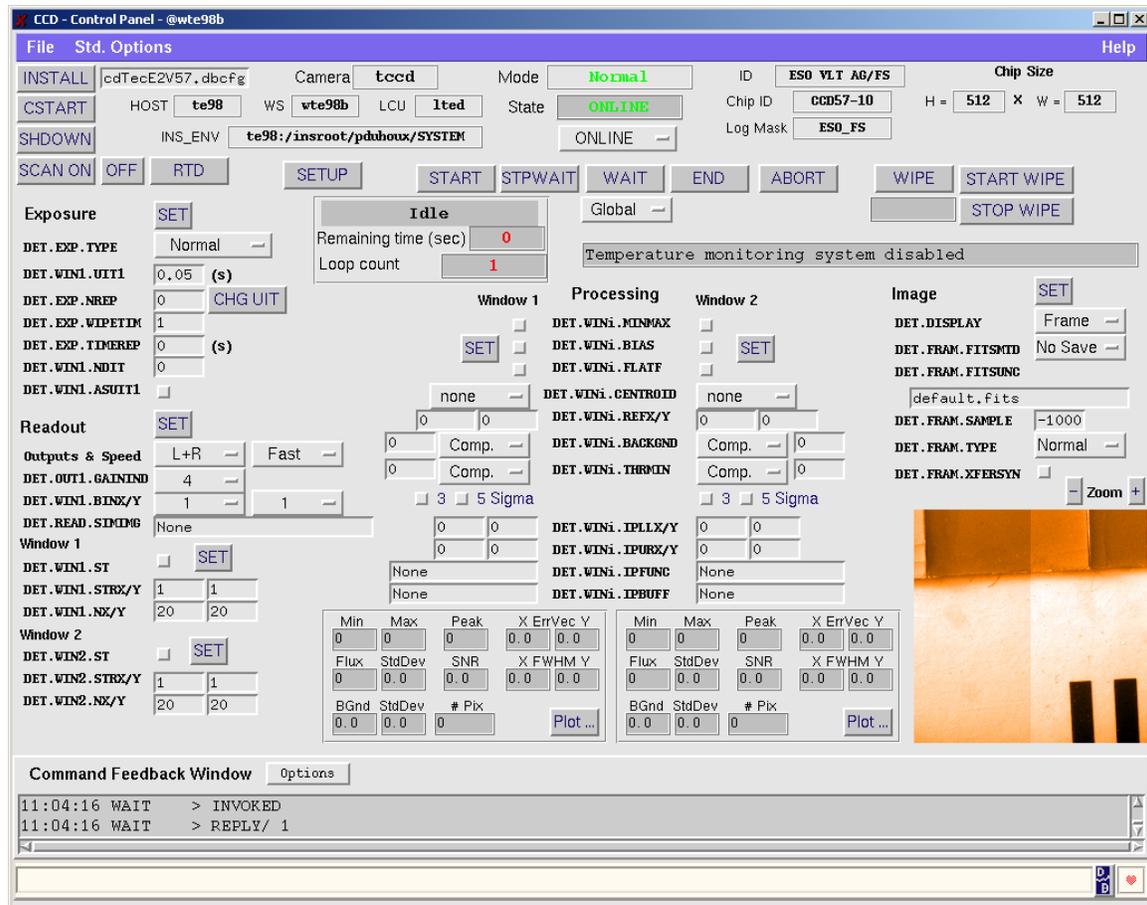
## 2.4c - New panel ccdCtrlNB

A dedicated panel has been developed for running on a Laptop (1024×788). It implements all the setup FITS keywords and includes a small RTD panel.
